**DEPARTMENT OF TRANSPORTATION****DIVISION OF ENGINEERING SERVICES**

Contract #: 04-0120F4Cty: SF/ALA Rte: 80 PM: 13.2/13.9File #: 1.28**WELDING INSPECTION REPORT****Resident Engineer:**Siegenthaler, Peter**Address:** 333 Burma Road**City:** Oakland, CA 94607**Report No:** WIR-022157**Date Inspected:** 25-Mar-2011**Project Name:** SAS Superstructure**OSM Arrival Time:** 700**Prime Contractor:** American Bridge/Fluor Enterprises, a JV**OSM Departure Time:** 1530**Contractor:** American Bridge/Fluor Enterprises, a JV**Location:** Job Site**CWI Name:** John Pagliero and Gary Ersham**CWI Present:** Yes No**Inspected CWI report:** Yes No N/A**Rod Oven in Use:** Yes No N/A**Electrode to specification:** Yes No N/A**Weld Procedures Followed:** Yes No N/A**Qualified Welders:** Yes No N/A**Verified Joint Fit-up:** Yes No N/A**Approved Drawings:** Yes No N/A**Approved WPS:** Yes No N/A**Delayed / Cancelled:** Yes No N/A**Bridge No:** 34-0006**Component:** Orthotropic Box Girder**Summary of Items Observed:**

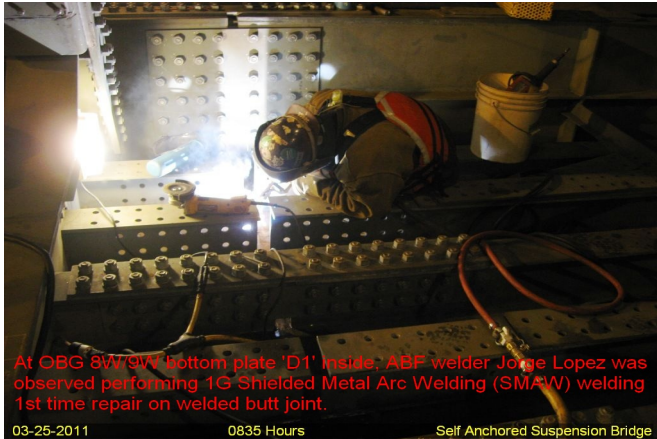
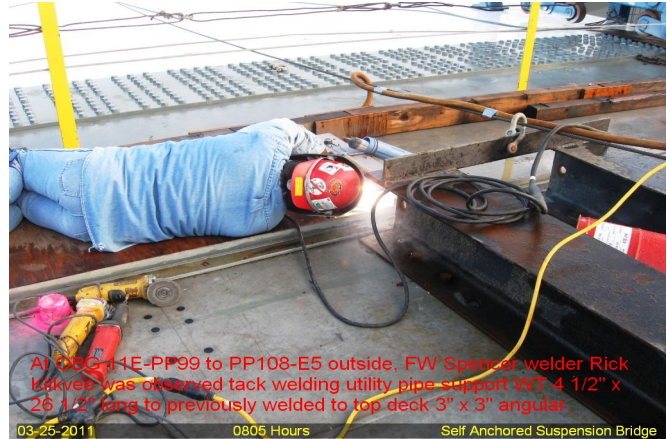
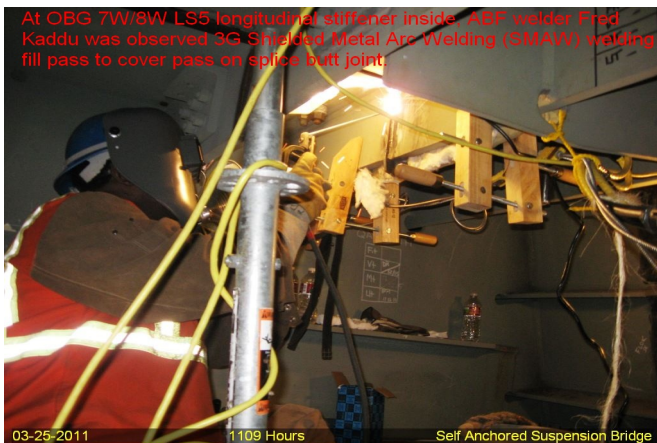
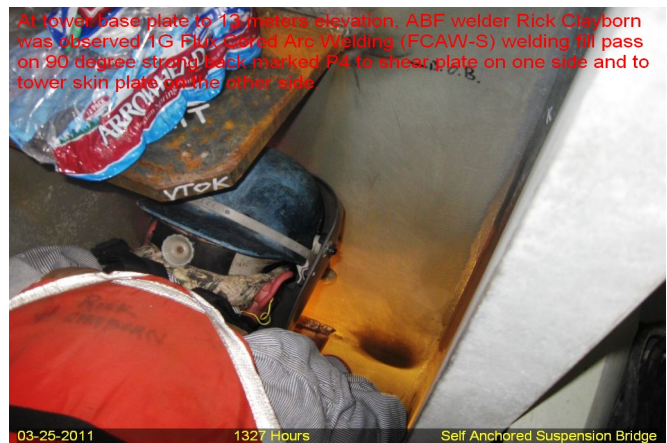
At OBG 10E/11E top deck plate 'A' inside, QA randomly observed ABF/JV qualified welder Hua Qiang Hwang and Wai Kitlai fix some of the gouges that were incurred during the tack welding of fitting gear/temporary attachments. The welders were noted smooth grinding the gouges using a flapper disk.

At OBG 8W/9W bottom plate 'D1' inside, QA randomly observed ABF/JV qualified welder Jorge Lopez perform CJP repair welding. The welder was noted welding in 1G (flat) position utilizing SMAW with 1/8" diameter E7018H4R electrode implementing Caltrans approved Welding Procedure Specification (WPS) ABF-WPS-D15-1001 Repair. The first time welding repair located at Y=550mm and having excavation profile of 120mm long x 30mm wide x 16mm deep was excavated to a boat shape profile and was tested with Magnetic Particle Testing (MT) prior welding. During welding, ABF QC Jesse Cayabyab was noted monitoring the welder and his welding parameters. QA noted parameter during welding was 148 amperes which appears in compliance to the WPS. At the end of the shift, welding repair at the location mentioned above was completed.

At OBG 7W/8W LS5 longitudinal stiffener inside, QA randomly observed ABF welder Fred Kaddu perform 3G (vertical) Shielded Metal Arc Welding (SMAW) complete joint penetration (CJP) welding fill pass to cover pass on the stiffener splice butt joint. The stiffener plates being welded are made of high strength plate material HPS 485W and has a thickness of 30mm. The joint has a double V joint preparation that was welded from one side and

At tower base plate to 13 meters elevation, QA randomly observed ABF welder Rick Clayborn perform root pass to cover pass welding Partial Joint Penetration (PJP) temporary strong back attachments . The welder was noted welding in 1G (flat) position utilizing self shielded Flux Cored Arc Welding (FCAW-S) with 0.072" diameter E71T-8 wire electrode implementing Caltrans approved Welding Procedure Specification (WPS) ABF-WPS-D15-2160 FCAW. The P4 marked strong back being welded is 90° strong back that was welded on shear plate on one side and to tower skin plate on the other side. The welder was noted welding at weld map location 19, 20, 23 and 24 at elevation 9 meters. During the shift, QA noted ABF QC John Pagliero was on site monitoring the in process preheats and welding parameters. At the end of the shift, PJP welding of the P4 strong back at various locations was still continuing and should remain Monday.
